***Augmented Report to LDM Consulting (Pty) Ltd on the  
Results of a Geotechnical Investigation for the Proposed  
Additions and Alterations at the uMalusi Council for  
Quality Assurance in General and Further Education and  
Training College, Pretoria, Gauteng***

***Reference: JHB031-19.R01  
Revision 2***

***Dated: 08 July2020***

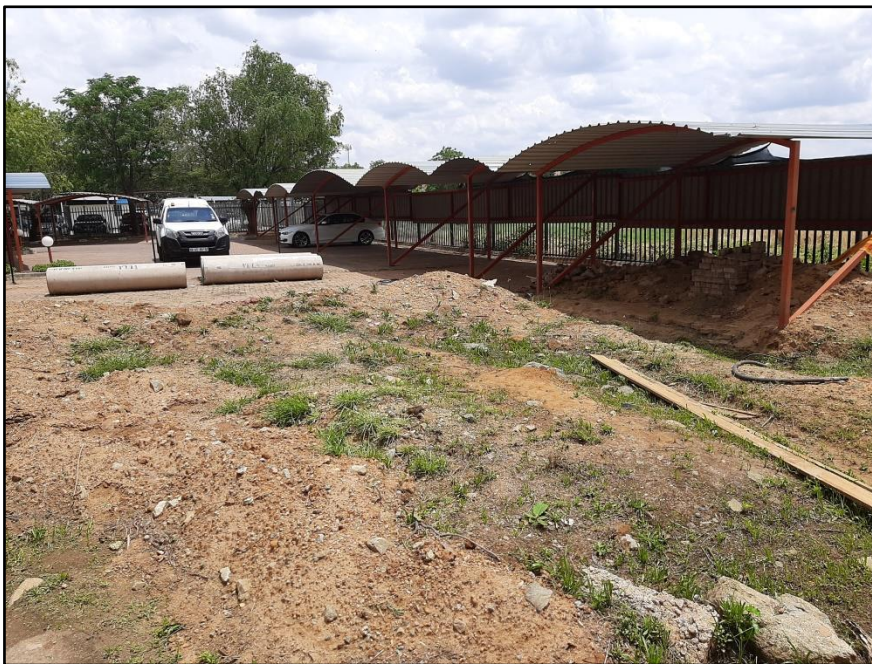
**Plate 2: View across the north western portion of the site**

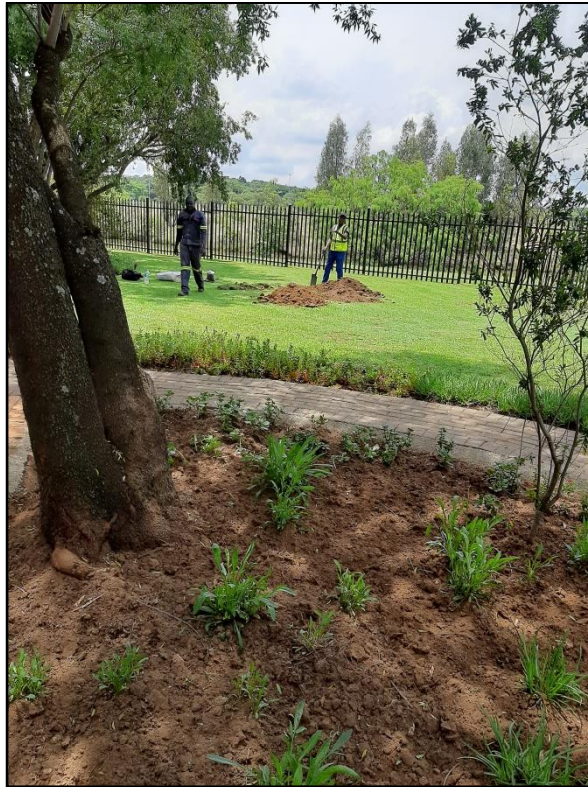
**Plate 3: View along the eastern portion of the site**

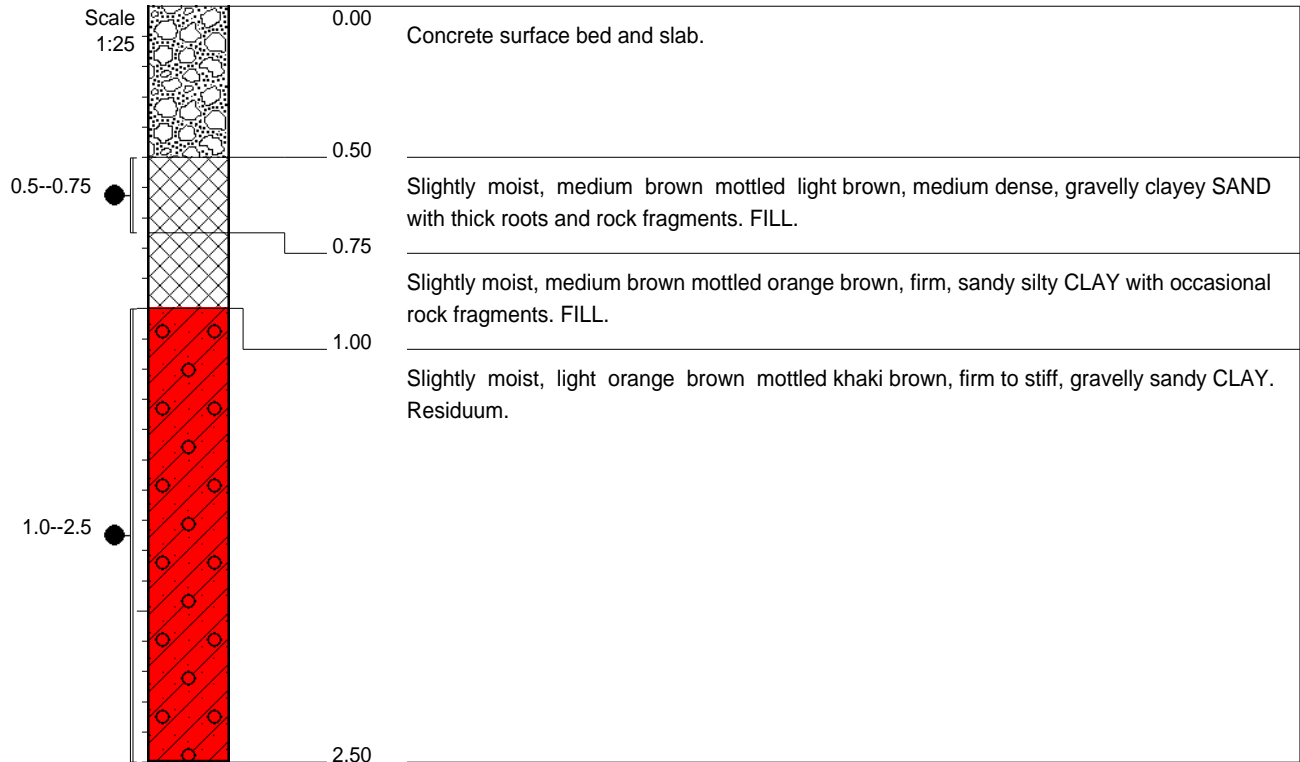
- 1) No groundwater seepage observed.
- 2) Samples taken at:  
 S1 0,5--0,75 (1 x Ind)  
 S2 1,0--2,5 (1 x Ind)
- 3) Inspection pit extended using hand auger from 1,1m below EGL.
- 4) Final depth at 2,5m below EGL.

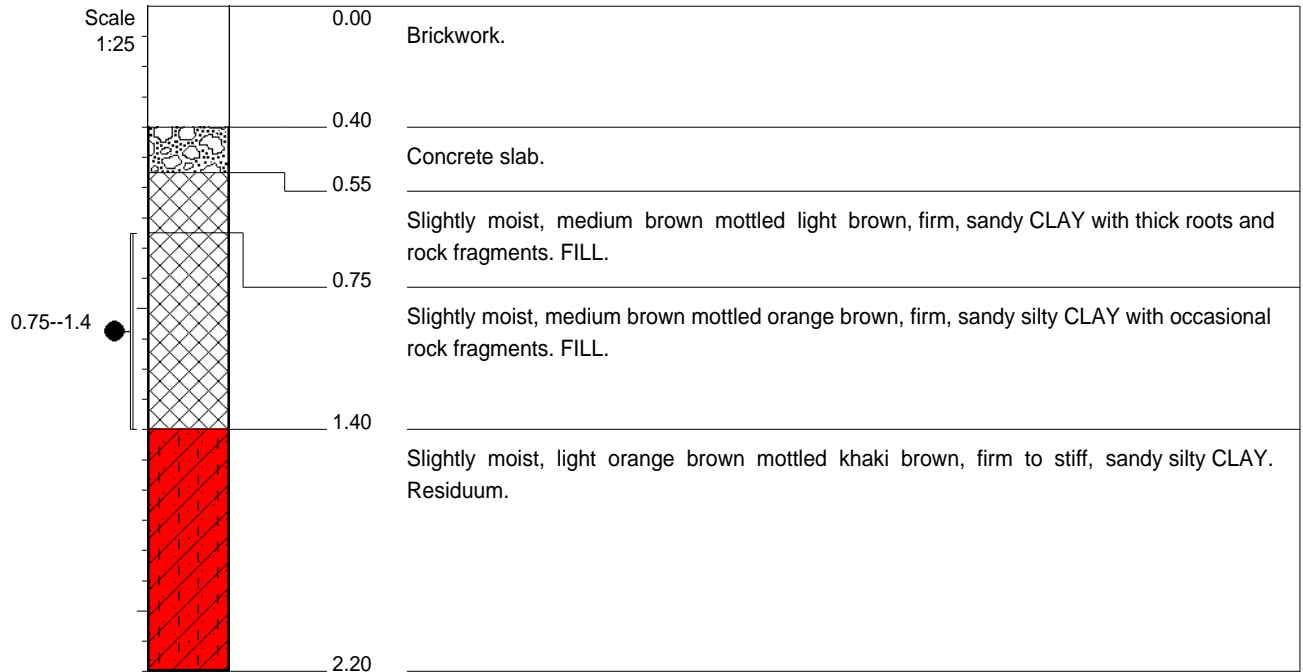
- 1) No groundwater seepage observed.
- 2) Sample taken at:  
S1 0,75--1,4 (1 x Ind)
- 3) Inspection pit extended using hand auger from 1,0m below EGL.
- 4) Final depth at 2,2m below EGL.

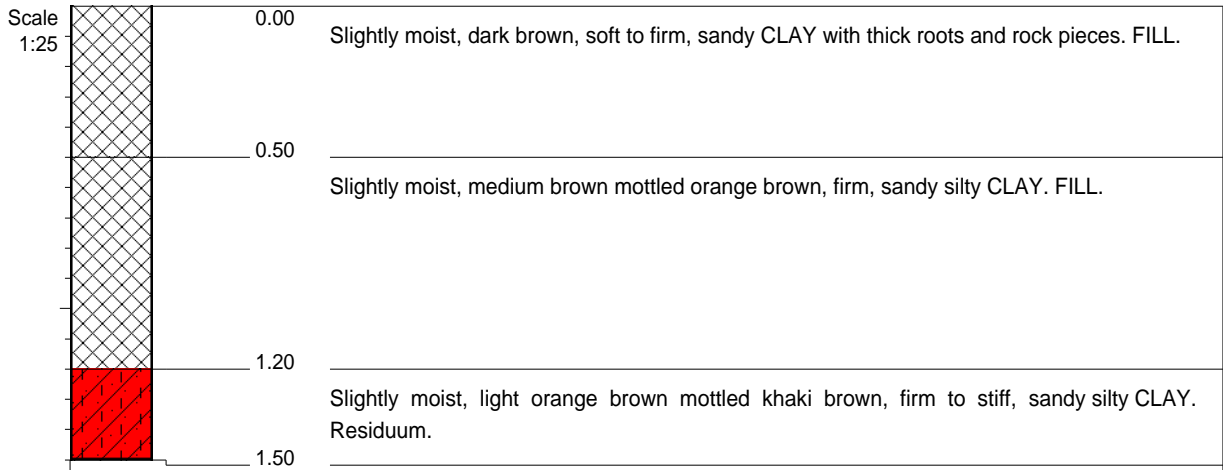
HOLE No: IP3  
 Sheet 1 of 1

- 1) No groundwater seepage observed.
- 2) Final depth at 1,5m below EGL.

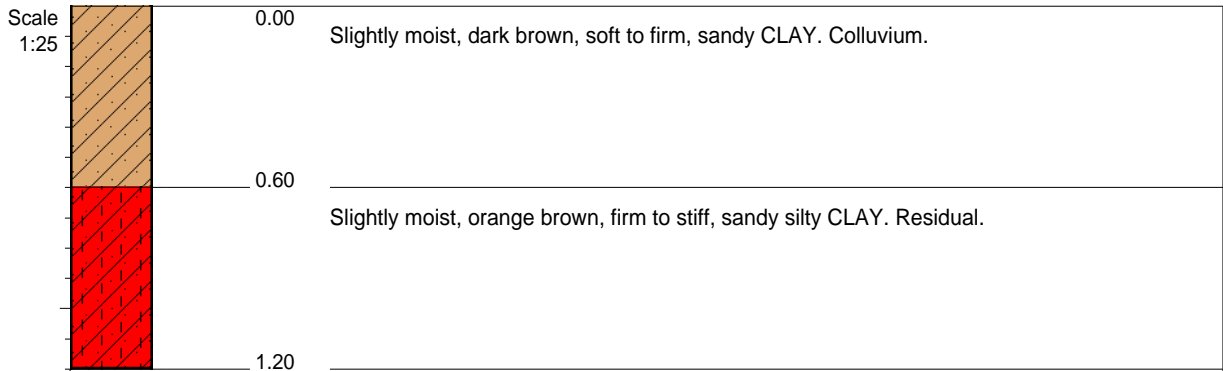
HOLE No: IP4  
Sheet 1 of 1

- 1) No groundwater seepage observed.
- 2) Slow advance of excavation.
- 3) Final depth at 1,2m below EGL.

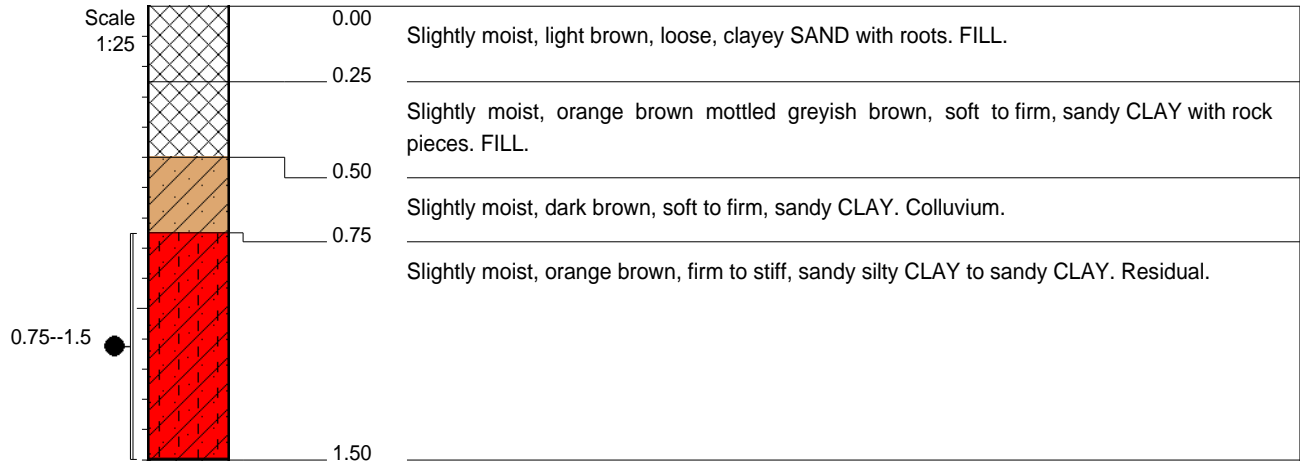
HOLE No: IP5  
 Sheet 1 of 1

- 1) No groundwater seepage observed.
- 2) Sample taken at:  
S1 0,75--1,5 (1 x Ind)
- 3) Final depth at 1,5m below EGL.

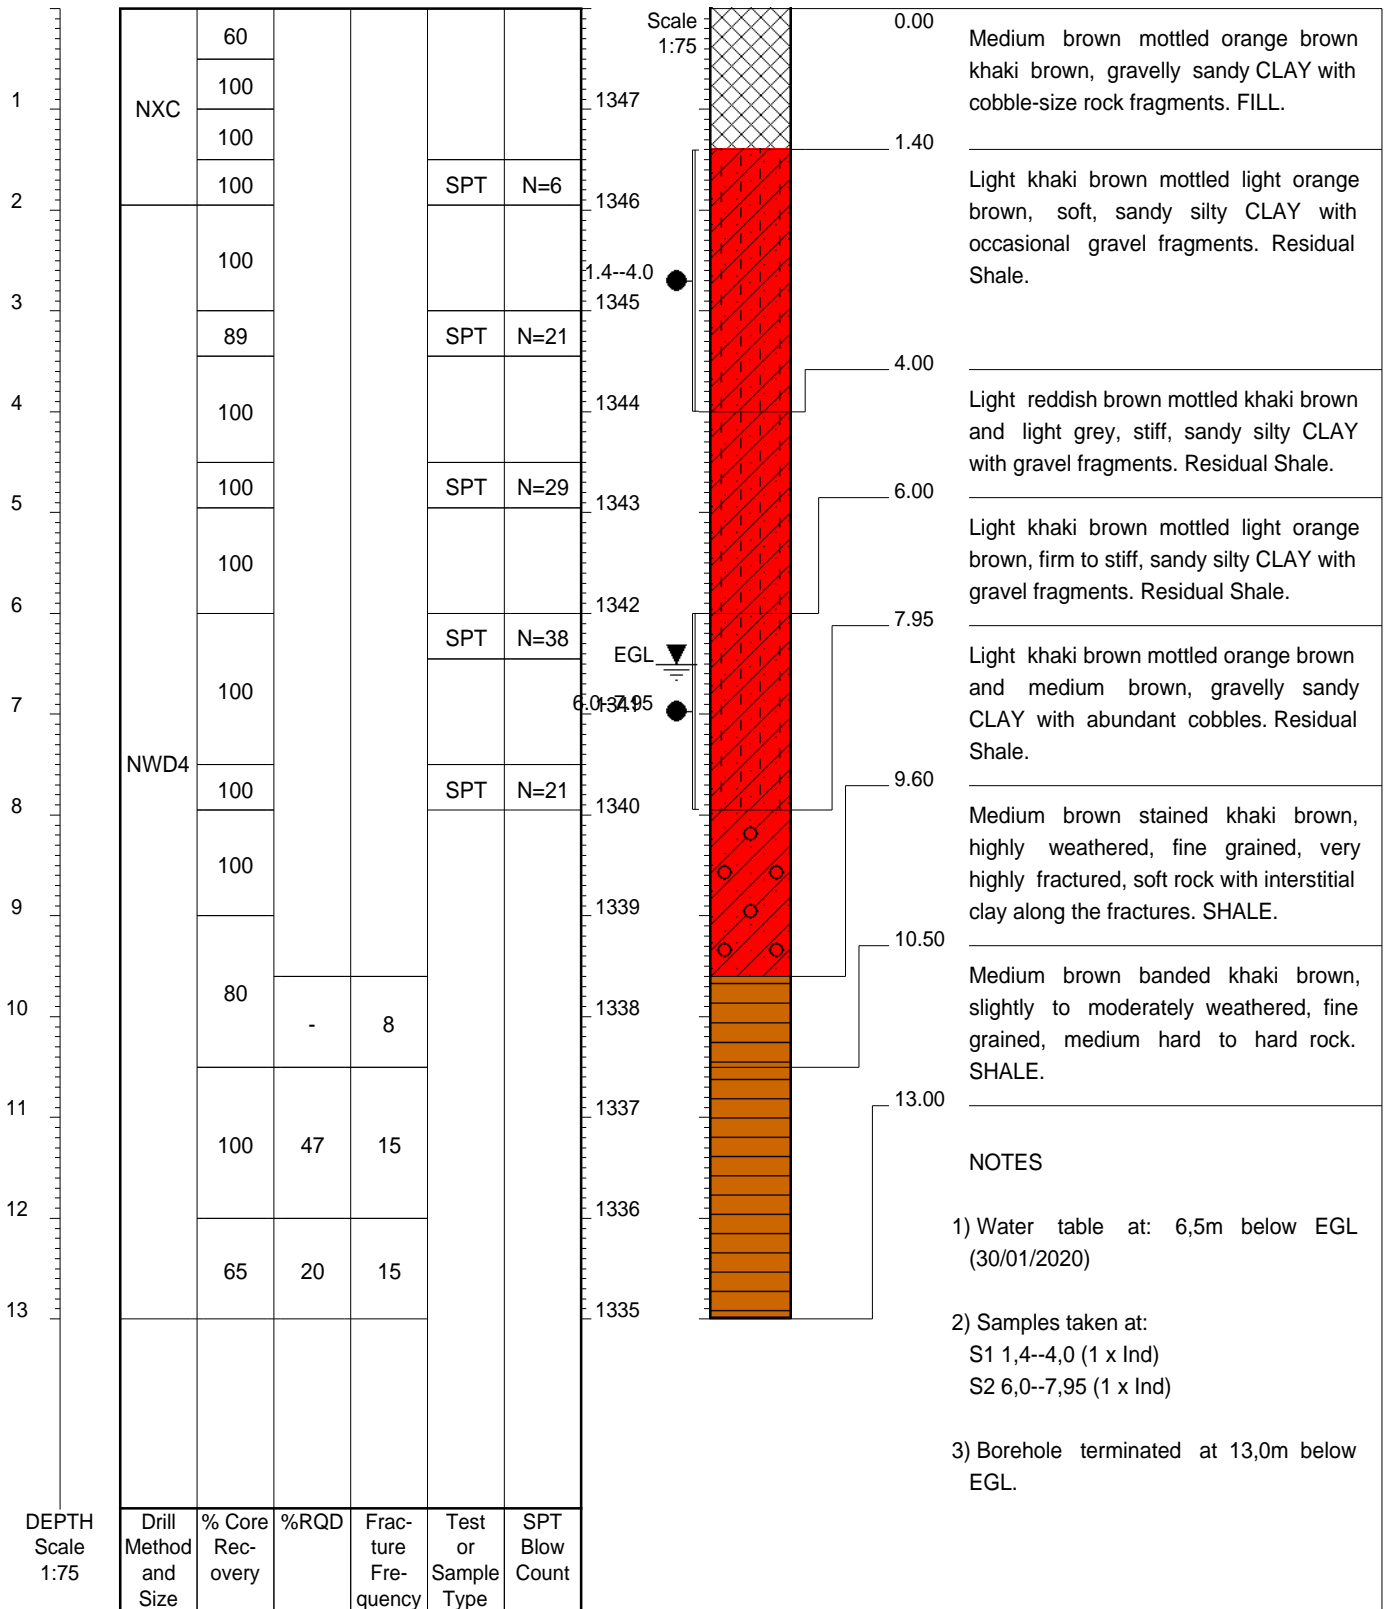
- 1) Water table at: 6,5m below EGL (30/01/2020)
- 2) Samples taken at:  
 S1 1,4--4,0 (1 x Ind)  
 S2 6,0--7,95 (1 x Ind)
- 3) Borehole terminated at 13,0m below EGL.
